Contractor Report ARAED-CR-96002

CRYOFRACTURE DEMILITARIZATION OF MUNITIONS (PHASE I)

September 1996

U.S. ARMY ARMAMENT RESEARCH, DEVELOPMENT AND ENGINEERING CENTER

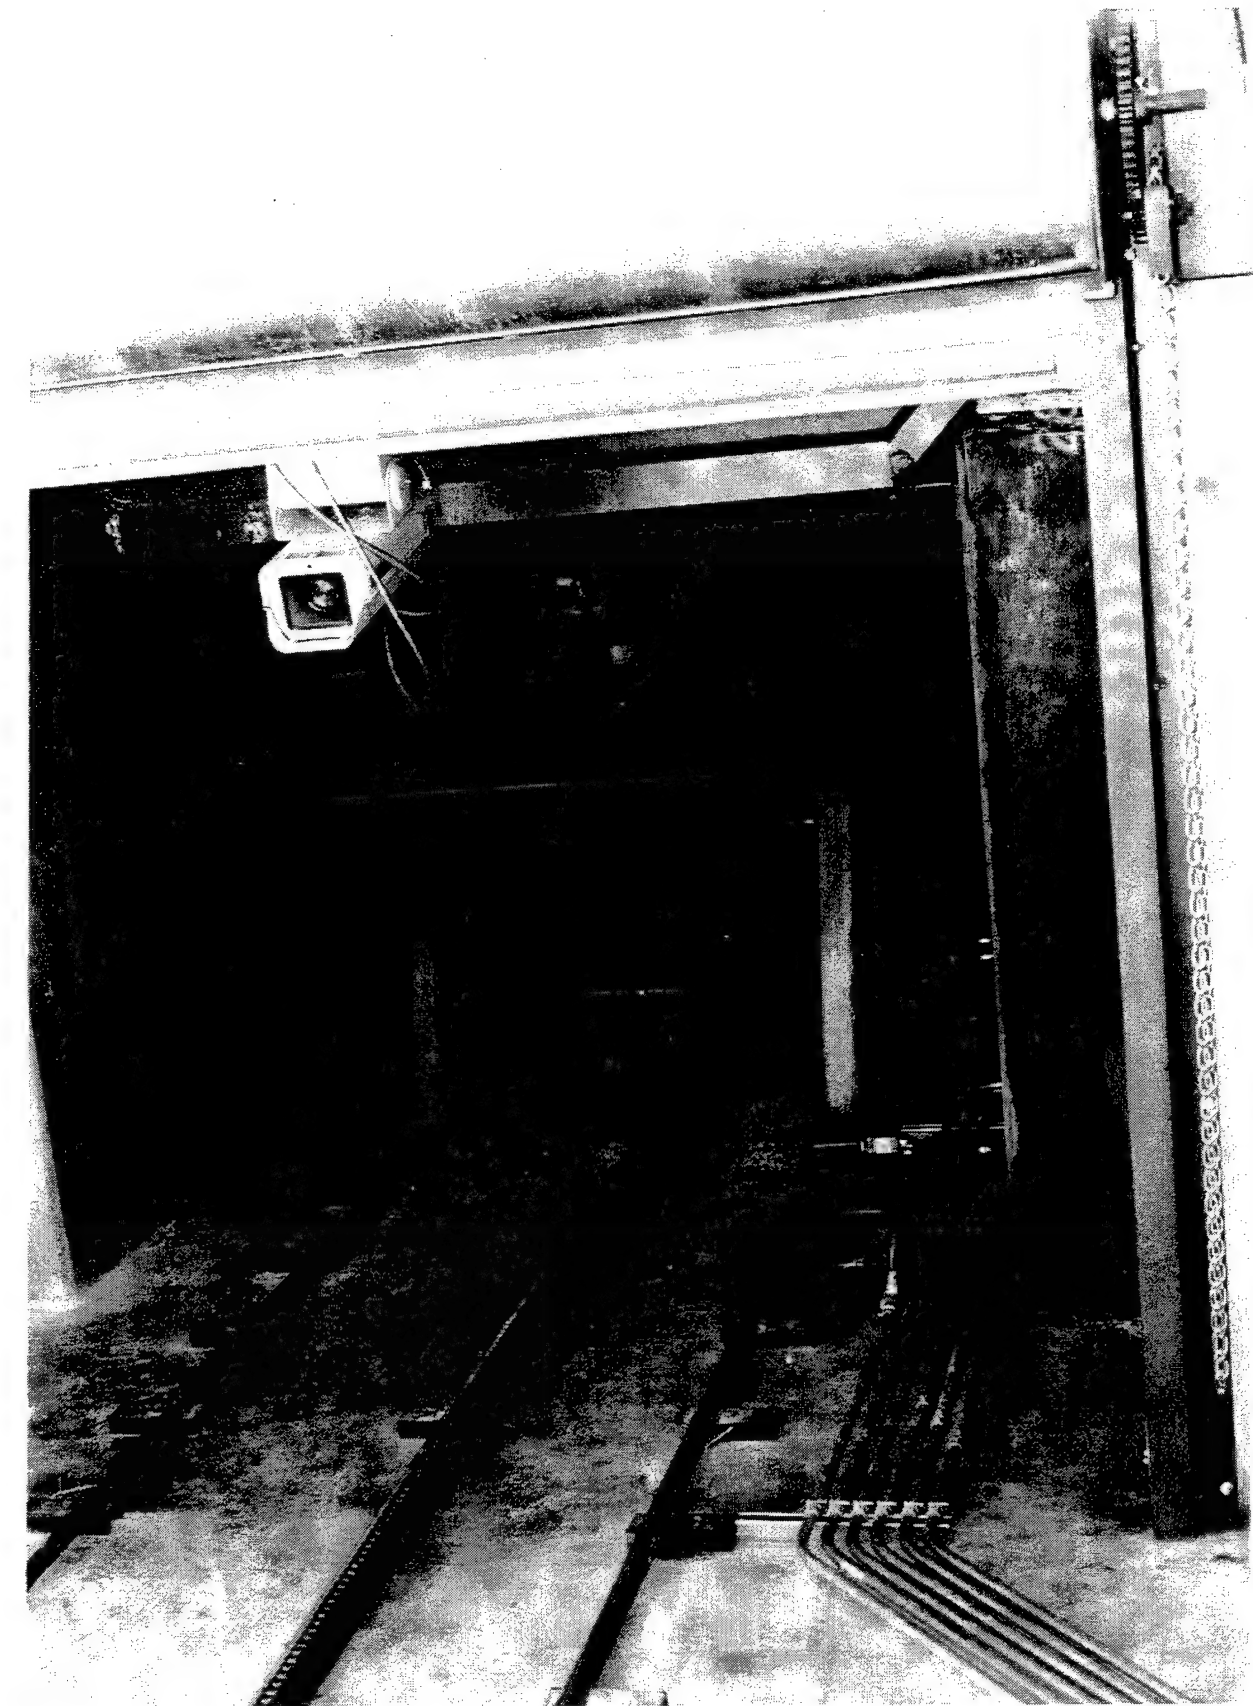
Figure 6
Fragment cart positioned under press discharge chute

Following fracture in the press, munition, and basket fragments drop into a custom designed chain-driven fragment cart (fig. 6). The remotely actuated fragment cart transports the fragments to the open grate furnace.

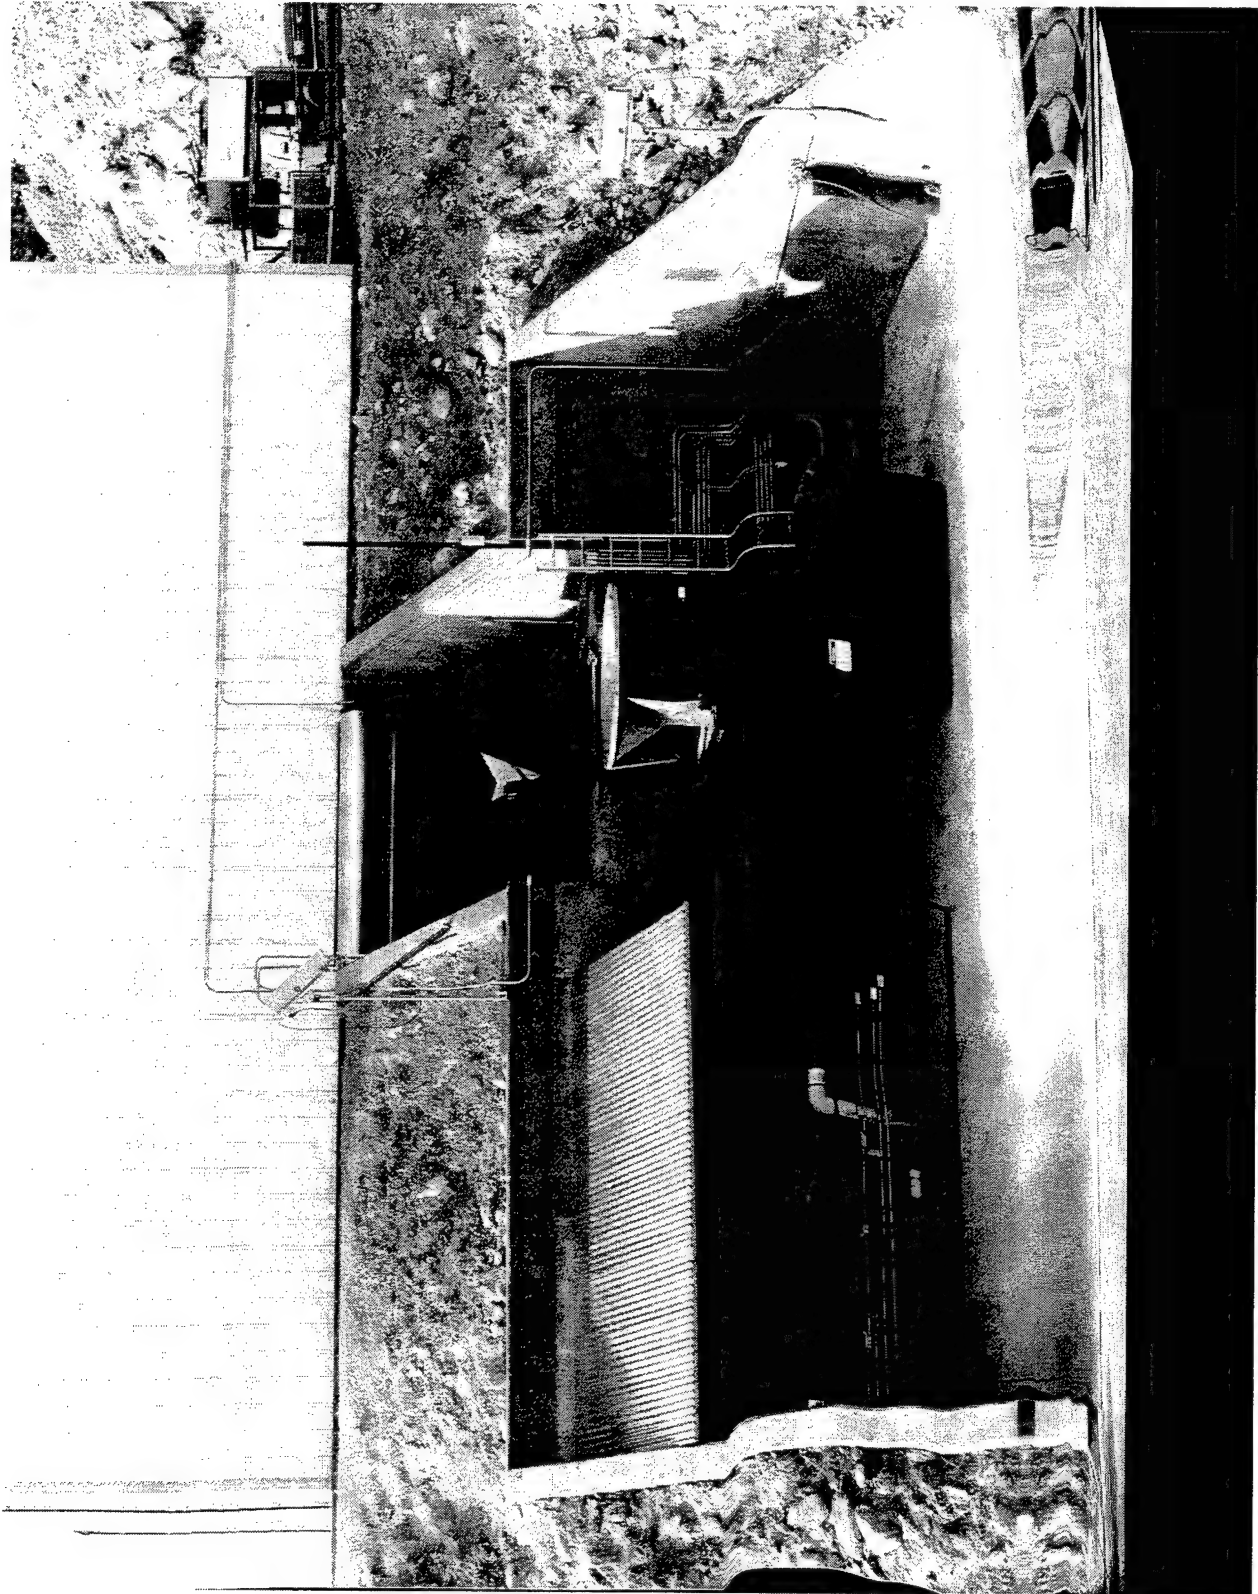
Figure 7
Open grate furnace

The custom designed open grate furnace is a two million BTU/hr, propane fueled, forced air unit (fig. 7). A centrifugal blower supplies combustion and excess air. The open grate contains a movable basket that permits the remote extraction of metal fragments after burning (fig. 8). The furnace grate is made up of three layers of grating material. The top two carbon steel grates are intended to provide a stand-off of burning material from the bottom Hastelloy X grate. The top two grates can be easily replaced if damage occurs. The fragments are dumped into scrap containers. Metal fragments are buried in a landfill after testing to verify that all explosives have been destroyed. Two 1,000 gal. tanks and a vaporizer supply propane to the furnace.
